RIVER CROSSING EXAMPLE

TOPOGRAPHICAL SURVEY WITH BATHYMETRIC SURVEY & UNDERGROUND UTILITY SURVEY

EX-T-6

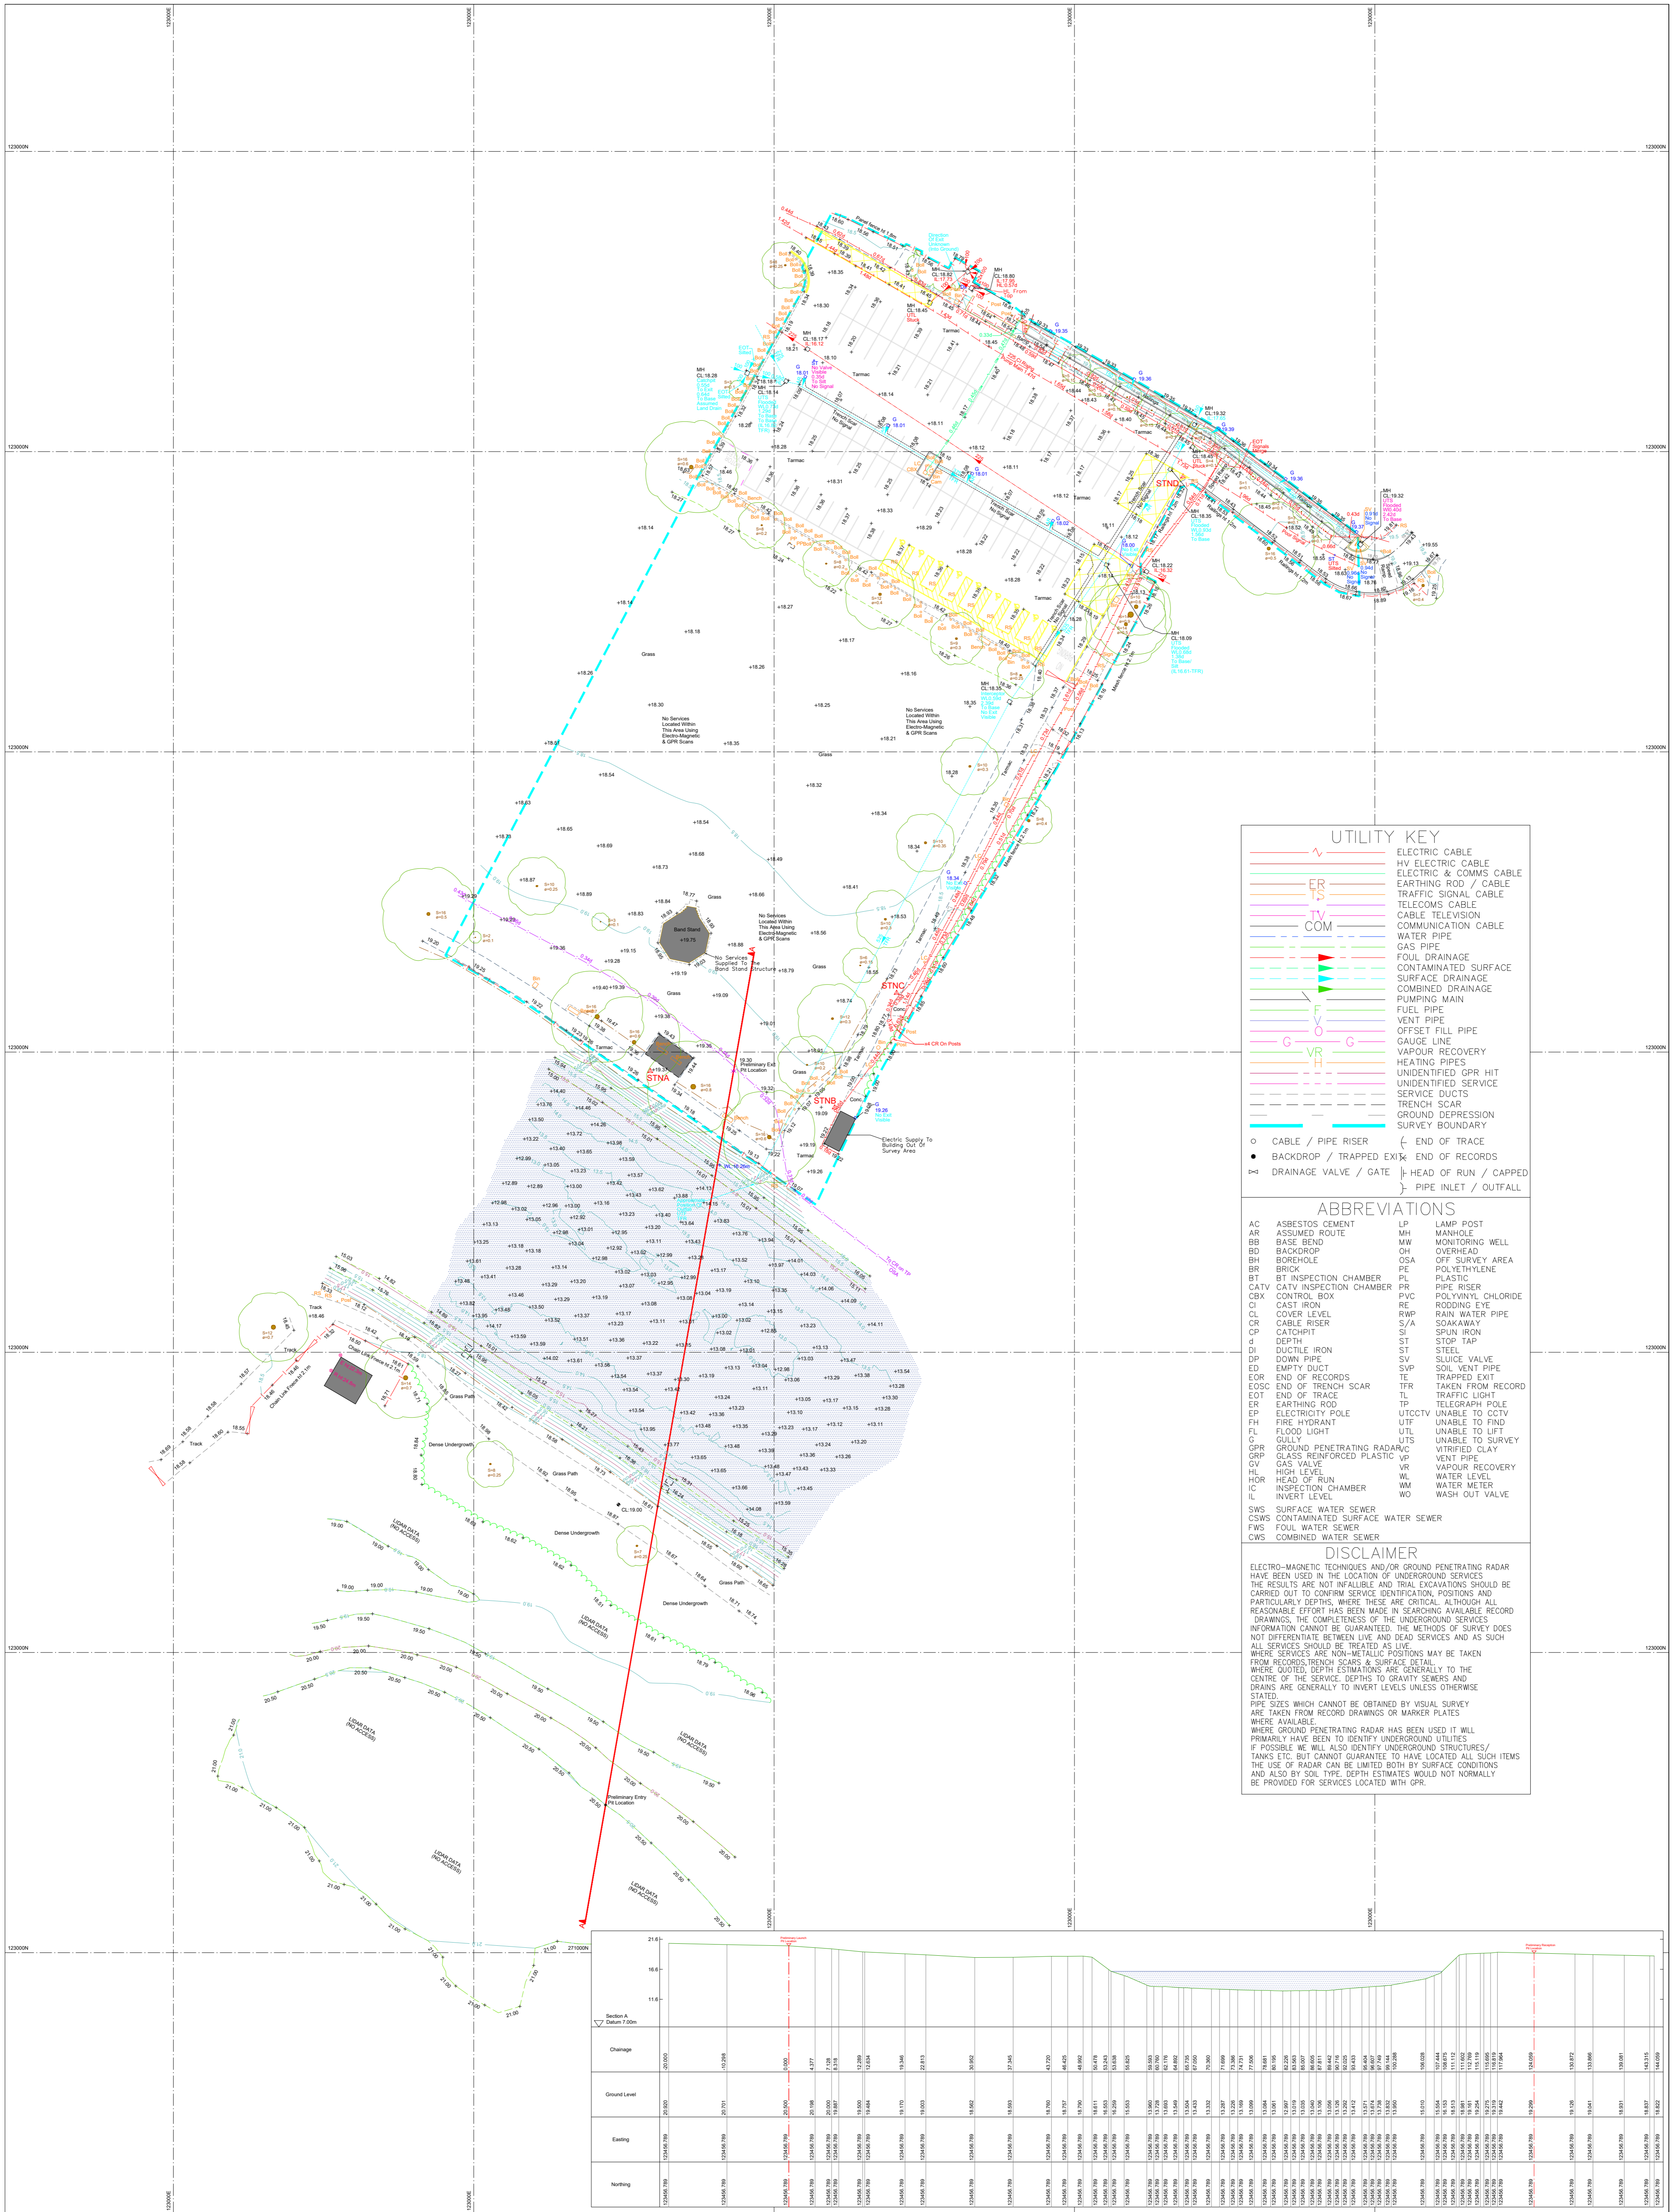
Section A
Datum 7.00m

Chainage	Ground Level	Easting	Northing
207000	19.00	123456.789	123456.789
207005	19.05	123456.789	123456.789
207010	19.10	123456.789	123456.789
207015	19.15	123456.789	123456.789
207020	19.20	123456.789	123456.789
207025	19.25	123456.789	123456.789
207030	19.30	123456.789	123456.789
207035	19.35	123456.789	123456.789
207040	19.40	123456.789	123456.789
207045	19.45	123456.789	123456.789
207050	19.50	123456.789	123456.789
207055	19.55	123456.789	123456.789
207060	19.60	123456.789	123456.789
207065	19.65	123456.789	123456.789
207070	19.70	123456.789	123456.789
207075	19.75	123456.789	123456.789
207080	19.80	123456.789	123456.789
207085	19.85	123456.789	123456.789
207090	19.90	123456.789	123456.789
207095	19.95	123456.789	123456.789
207100	20.00	123456.789	123456.789
